Manhole Inspection Summary

Manhole # S53M__036MH

Insp Date: **7/21/08 1:49 PM**

Location Address: **rear 940 s bouldin st**

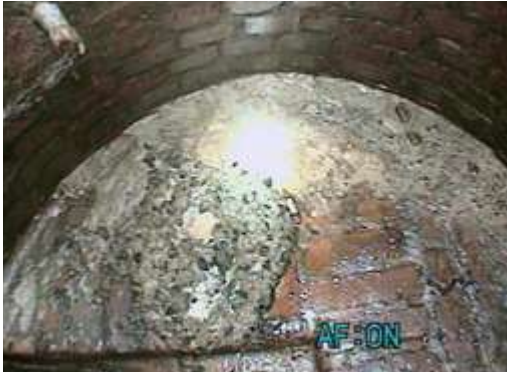
misc

bench debris

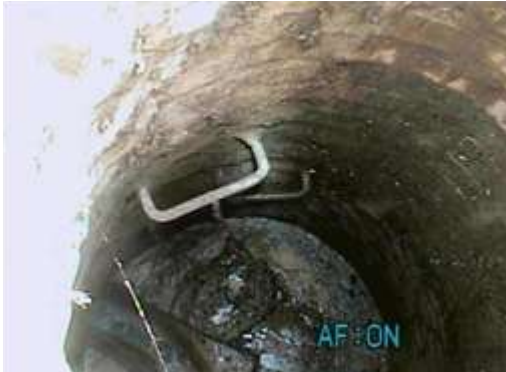
Defect 3

Steps Count: **3** Missing: **0** ☒ **Corroded**

steps

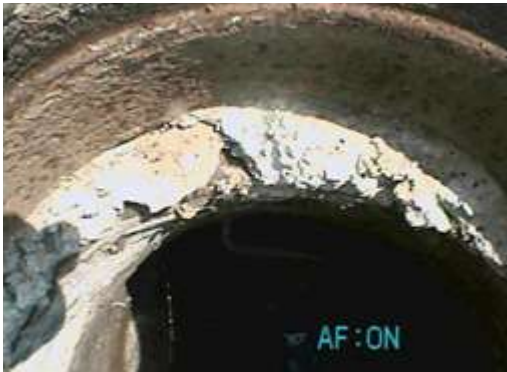
Defect 2

Frame Offset: **3** (in.) Condition: ☒ Sound ☐ Cracked ☐ Leaks

offset

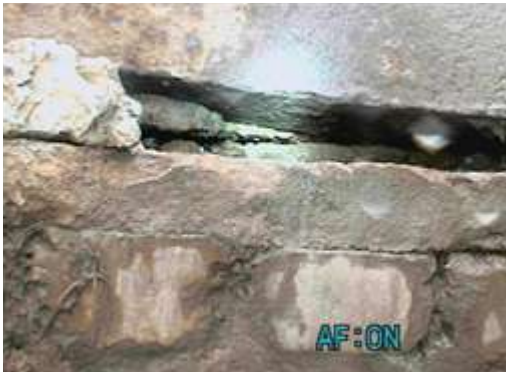
Defect 1

Condition: ☐ Sound ☐ Cracked ☐ Root Intrusion ☒ **Loose Brick** ☐ Deteriorated

loose bricks, frame adj

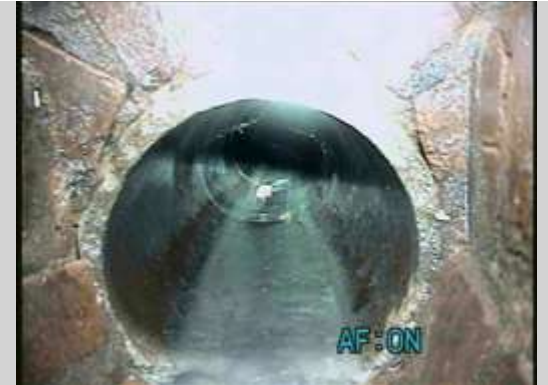
12 O'Clock Outflow

8 in. Circular Gravity Sewer
Pipe Out @ 12 O'Clock

Invert Depth: **8.40** (ft.) Flow Characteristics: **Fast**

Infiltration: **None** Pipe Seal Cond: **Unknown**

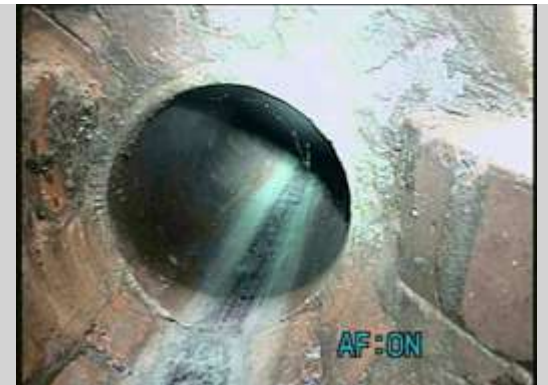
8 O'Clock Inflow

8 in. Circular Gravity Sewer
Pipe In @ 8 O'Clock

Invert Depth: **8.30** (ft.) Flow Characteristics: **Fast**

Infiltration: **None** Pipe Seal Cond: **Unknown**
